Instruction manual

VW 2.0 TSI Scirocco 147 kW, EOS/Golf VI, Passat, Scirocco 2.0 TFSI 155 kW, T5 2.0 TSI, Tiguan 2.0 TSI 132 / 155 kW

The **KW-unit** modifies the injection system by fine tuning the duration of the injectors. This is achieved by blue printing the original characteristics and intercepting the electronic signals from the ECU to the injection system. The fuel injection and engine speed are recorded and recalculated to optimize performance.

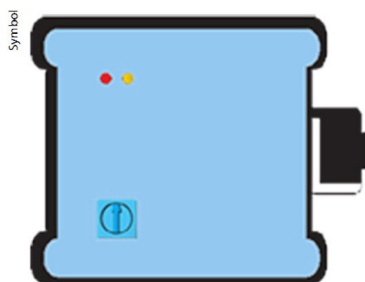
KW-unit opened

Control of function

LED: = ON = flashing = OFF

1 Ignition on (do not start engine)

- rt - power supply correct
- rt - power supply not correct or electronic defect
- ge - LED flashes slowly on idle setting of electronic pedal sensor (0,5 – 1 V)
- flashing frequency raises on full loading setting (3 V-4,9 V)
- ge - Reference signal connected incorrect (> 5V)
- ge - Reference signal connected incorrect (< 0,5V)

2 Start engine

- rt - the flashing frequency raises according to engine speed
- rt - check wiring loom; if installed correct, electronic defect
- rt - electronic defect
- ge - Switch closed position (off) = original power
- ge - Switch open position (on) = power enhancement

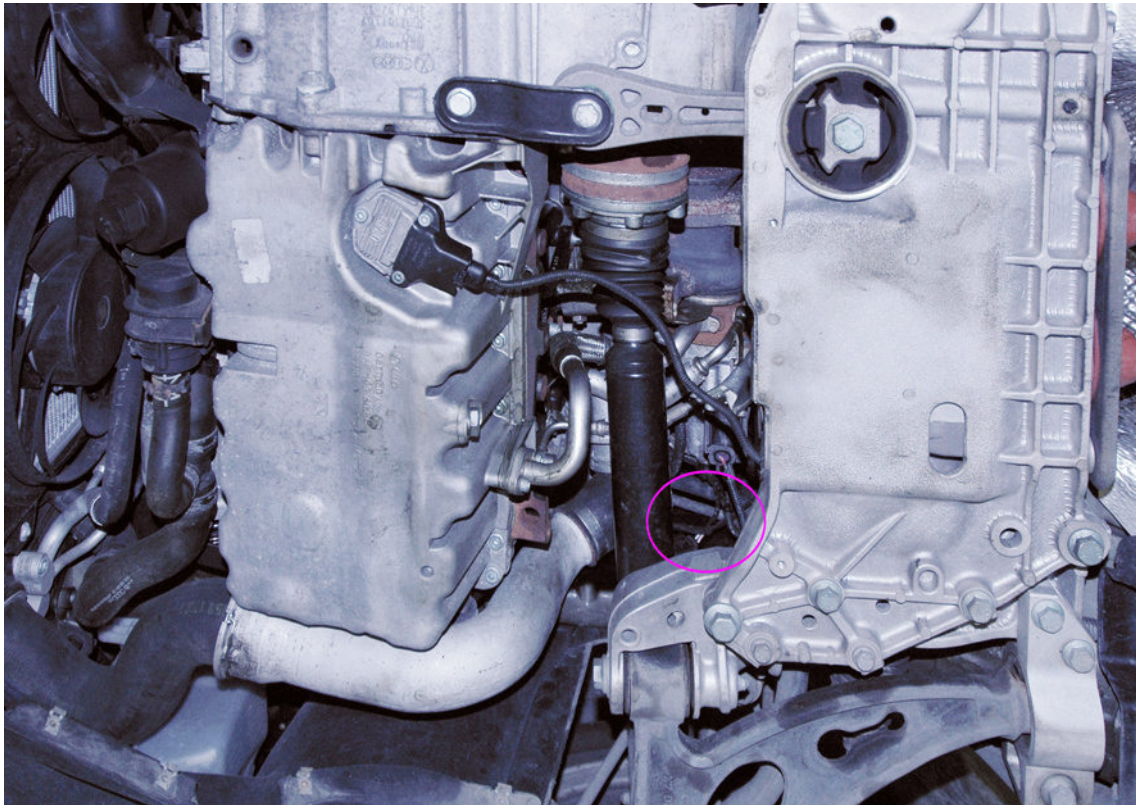
Turbo control valve, picture taken from the bottom

1. Driving direction.
2. Remove the engine cover.
3. Disconnect the plug connection at the turbo control valve from the bottom.
4. Disconnect the plug connection at the boost pressure sensor.
5. Disconnect the plug connection at the camshaft sensor.
6. Disconnect the plug connection at the rail pressure sensor.
7. Plug in the connectors of the **KW-unit** wiring loom.
8. Connect the red wire to the battery positive (+) terminal and the black wire to the battery negative (-) terminal.
9. Reference signal wire (see „Connection for the reference signal“)
10. Position and secure the **KW-unit** at the battery.
11. Refit the engine cover.
12. Switch wire. It is to turn on/off the additional horse power by the remote control. This RC-unit is an extra part you can order.

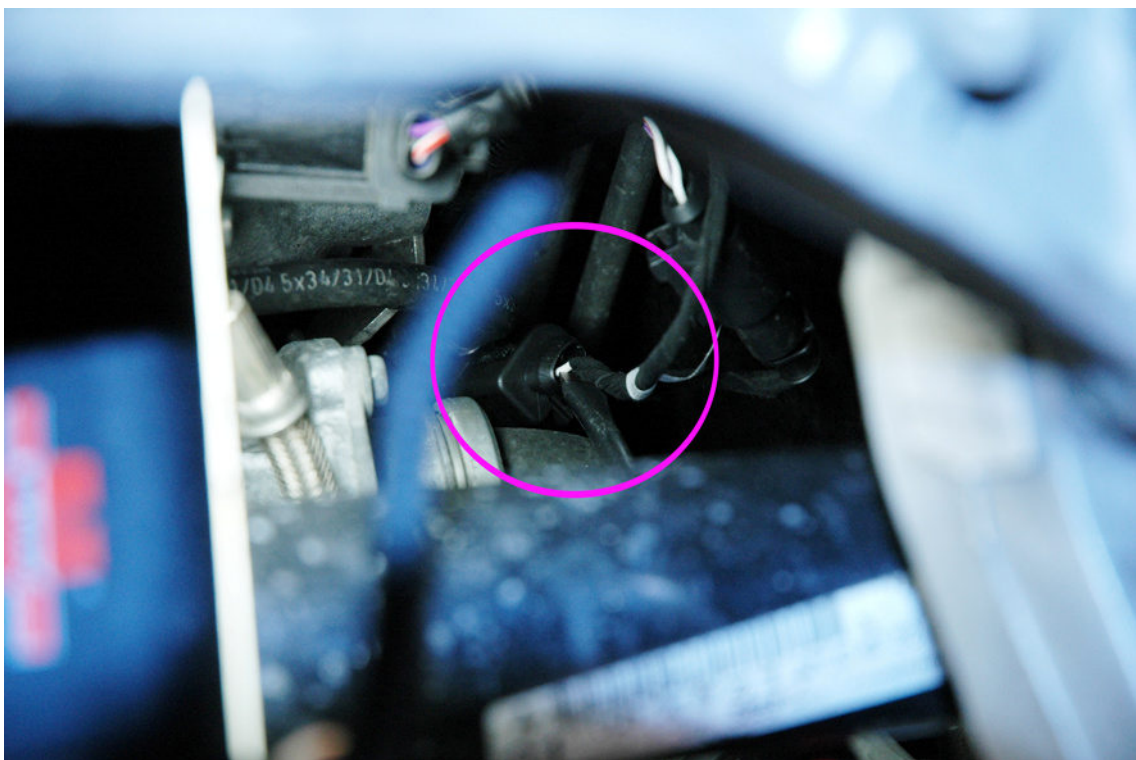
Turbo control valve picture taken from above
